AN INVESTIGATION OF THE S/N FATIGUE LIFE GAGE

SUBMITTED IN PARTIAL FULFILLMENT OF THE
REQUIREMENTS FOR THE DEGREES OF
MASTER OF SCIENCE
AND
NAVAL ENGINEER

at the
MASSACHUSETTS INSTITUTE OF TECHNOLOGY
June 1967

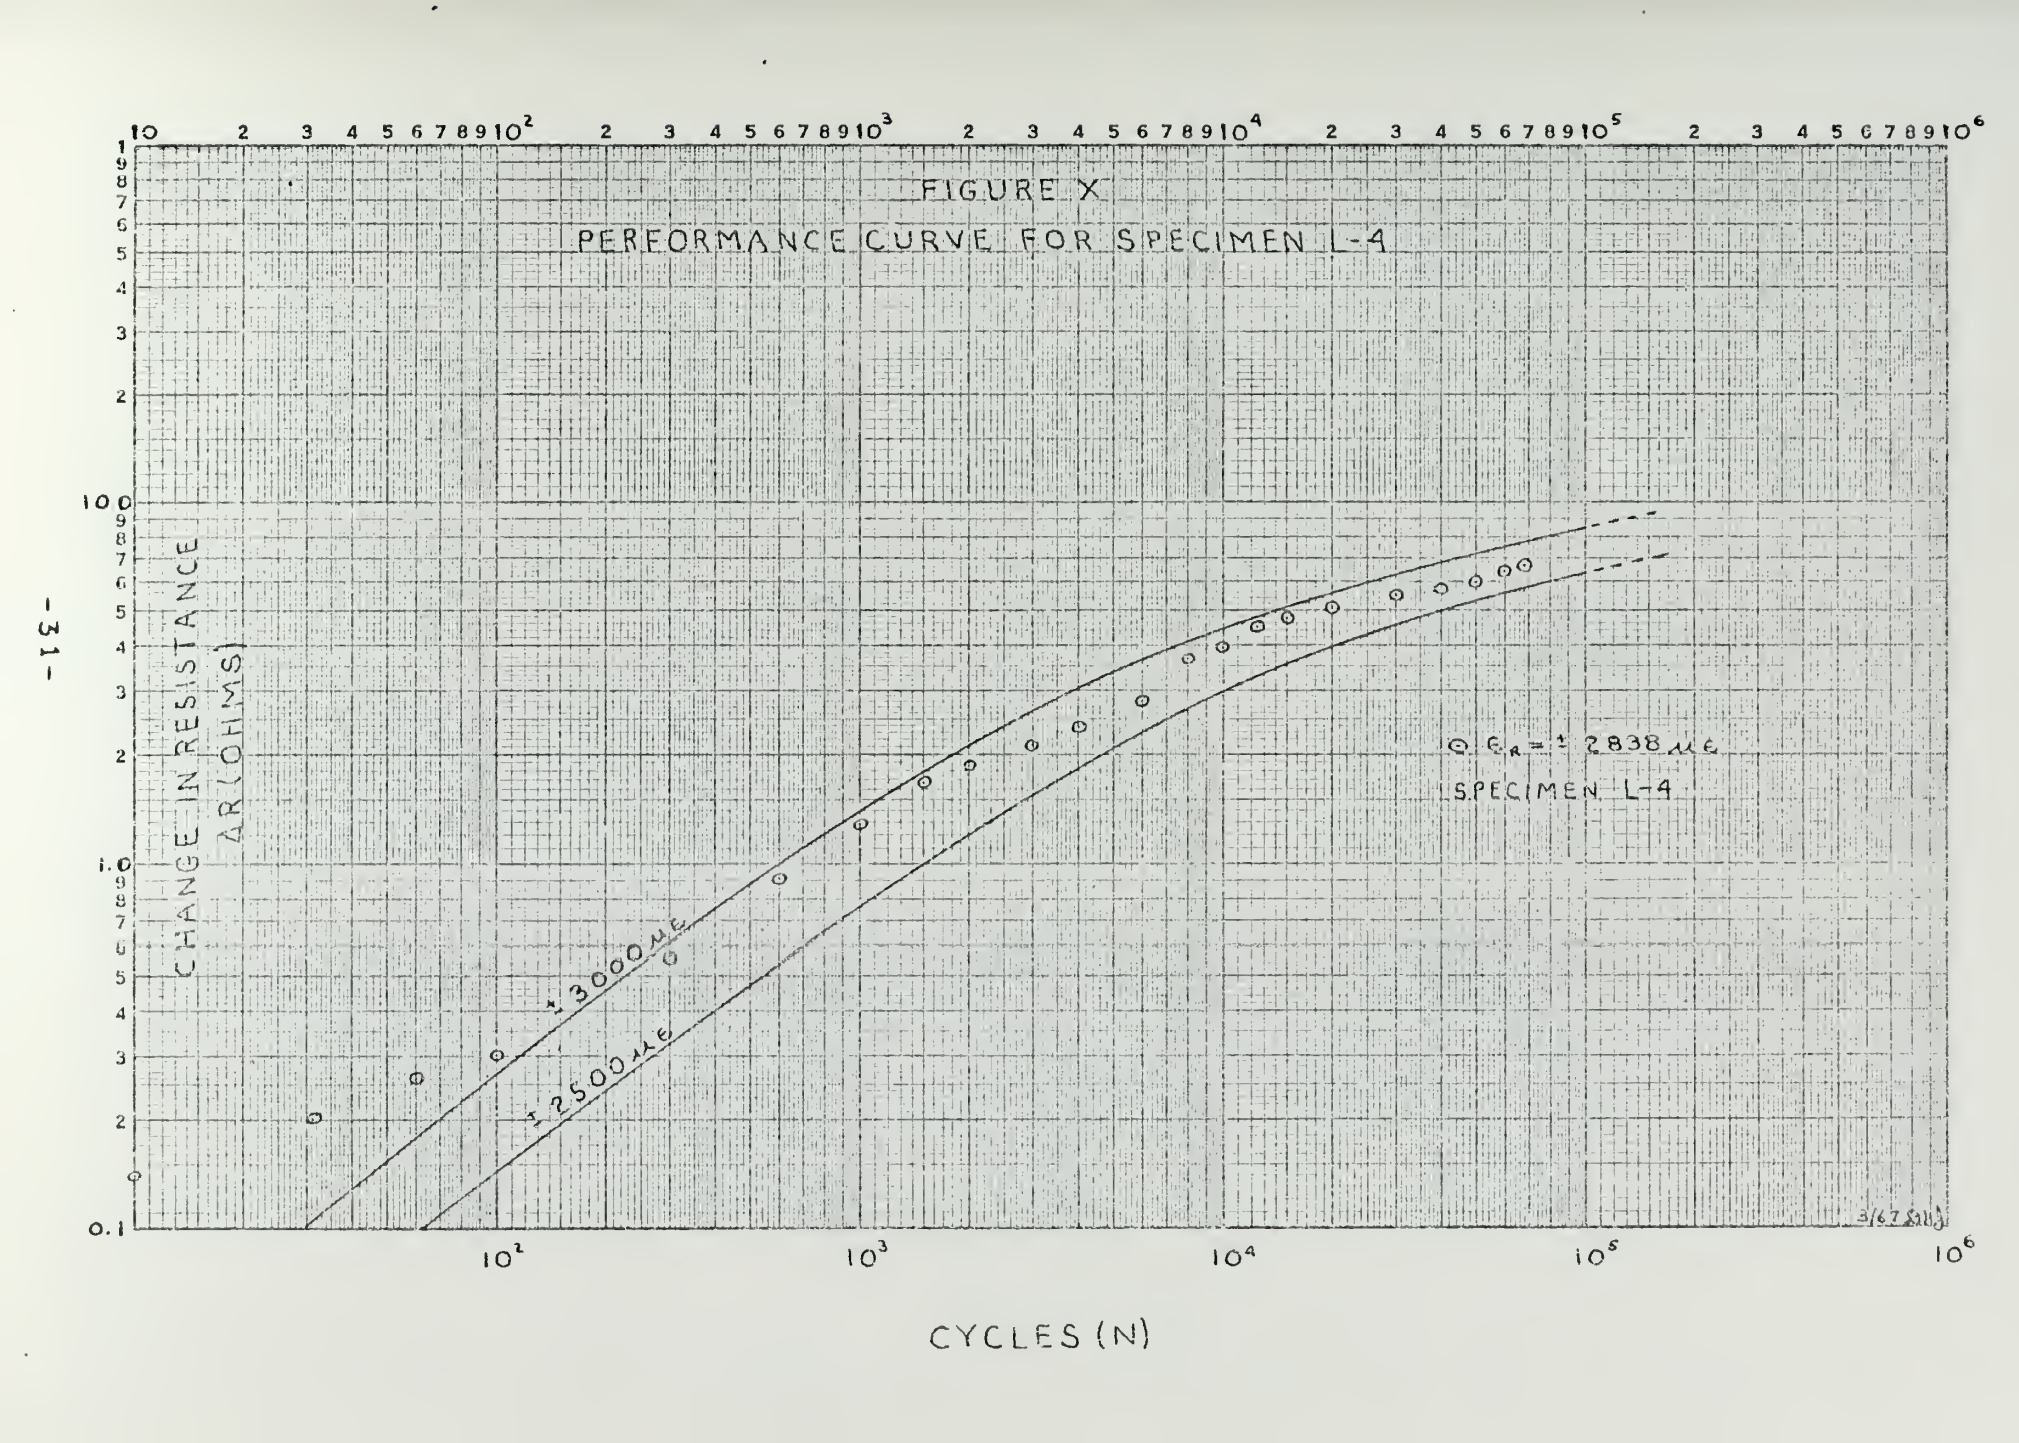
FIGURE X
PERFORMANCE CURVE FOR SPECIMEN L-4
CHANGE IN RESISTANCE ΔR (OHMS)
CYCLES (N)
± 3000 με
± 2500 με
⊙ εR = ± 2838 με
SPECIMEN L-4

Other phenomena were noticed that could cause an unexpected increase in the slope of $\Delta R/N$. Specimen L-4 had a rather large void in the lead turret which may have contributed to the ocillating effect in the performance curve. If the life of the specimen had been longer, a permanent ΔR deviation may have been noticed. If voids exist in the lead turret, they could certainly cause unpredictable effects as the void geometry changes due to cold working.

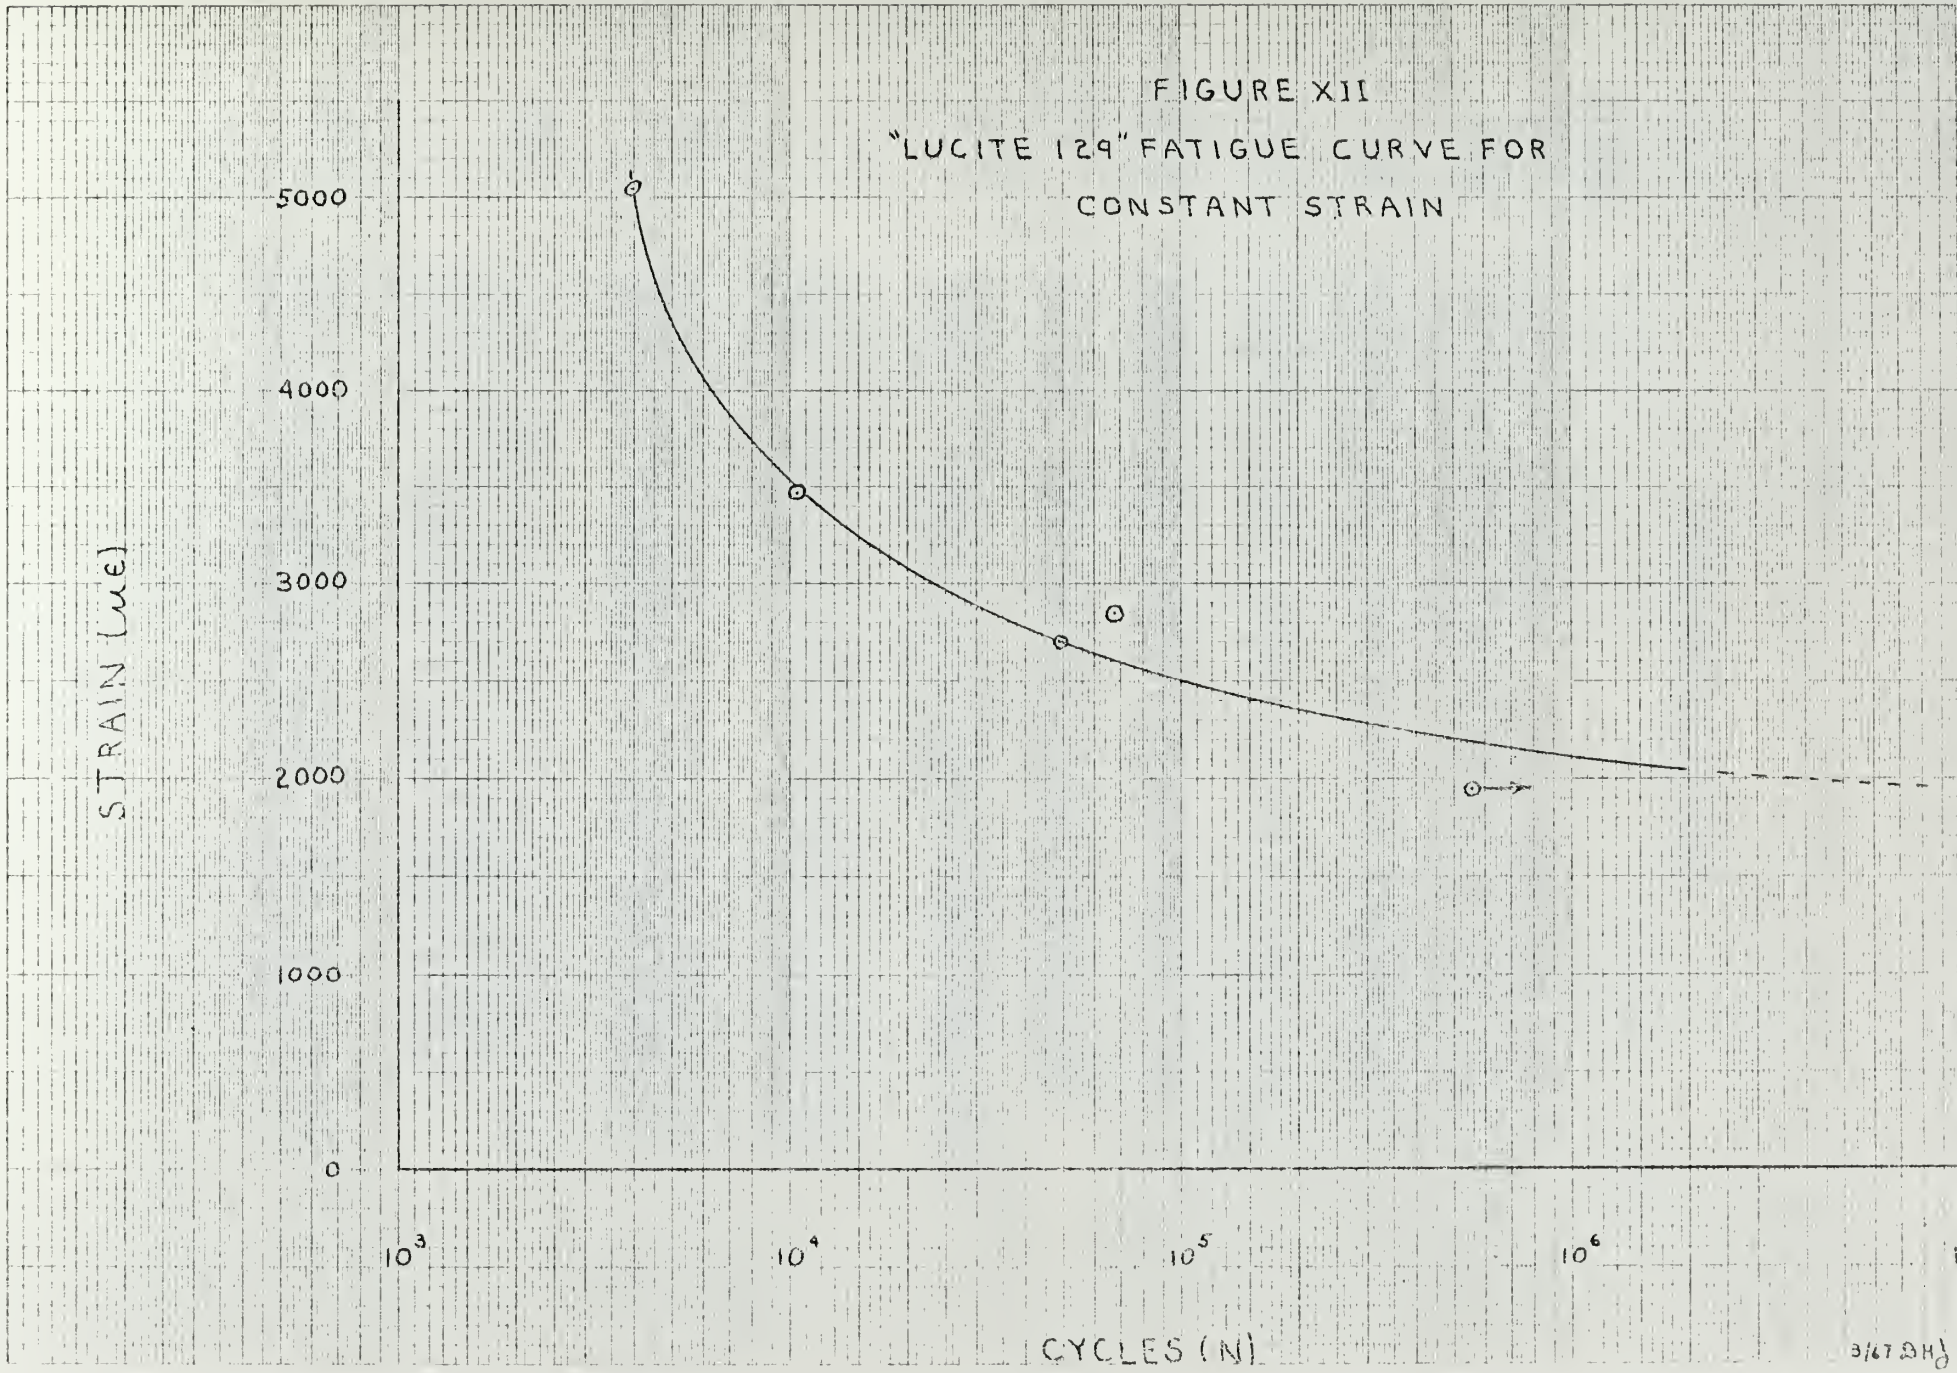
FIGURE XII
"LUCITE 129" FATIGUE CURVE FOR
CONSTANT STRAIN
STRAIN (με)
5000
4000
3000
2000
1000
0
10^3
10^4
10^5
10^6
CYCLES (N)

When the fatigue gage is mounted on Lucite, the specimen will not fail at the gage but at some point just past the gage. It appears from Figure XII that "Lucite 129" will have a long fatigue life below strain levels of 1900$\mu\varepsilon$.

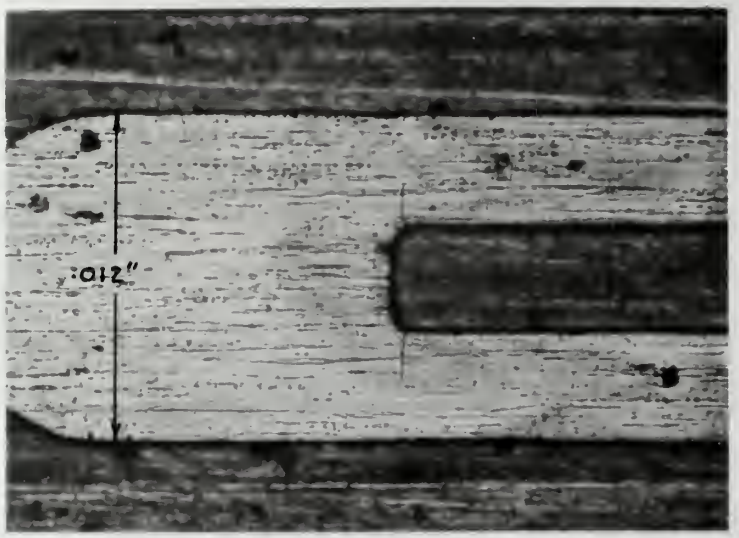
FIGURE XIII

The strain level of this test was $\pm 3157 \mu\epsilon$ for reverse bending. When the test was stopped at 6000 cycles, a definite but small zero shift in gage resistance was noticed. At 10,000 cycles the resistance had increased even more, but was still quite small; however, between 10,000 cycles and 15,250 cycles a sharp increase occurred in gage resistance. At this point the EA strain gage was studied with a metallograph. Cracks were observed in every strand as pictured in Figure XIII and Figure XIV. Figure XIII was photographed at 100X, and Figure XIV is the same field of interest at 200X. The mean crack length at the

tip end was .00116 inch and at the base end was .00196 inch. The maximum crack length was .00315 inch or 78.8% of the width of that strand. Every crack propagated from the same area as noted in Figures XIII and XIV. It appears that the cracks are caused by stress concentrations. Since the gage was not studied at the inception of zero shift, this test did not determine whether or not cracks had developed when the zero shift occurred. Using the criteria that a strain gage is near the end of its life when zero shift occurs (29), the EA gage should not be used after 6000 cycles in this case.

Two points are brought out by the crack observations. First, if a crack occurs, it will occur in the same area as noted in Figures XIII and XIV. Second, the mechanism causing small changes in resistance (i.e. 1% - 2%) of a foil gage can be attributed to cracking and not just work

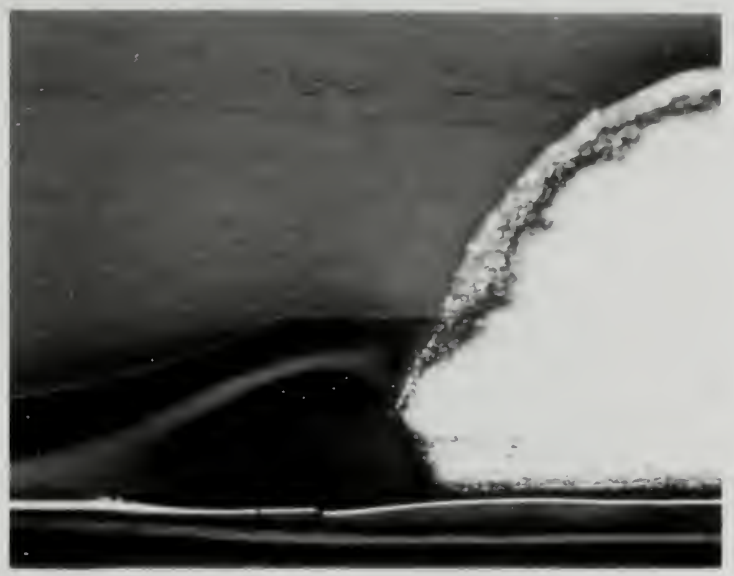
FIGURE XXVI

to the turret helped contribute to this phenomena. The void is shown in Figure XXV at 100X and Figure XXVI at 200X. The photographs show a crack in the foil grid below the void. The crack could have developed during polishing because the foil was not rigidly constrained at that point. The cause for the crack cannot be readily ascertained, but the crack is long enough that it could not be polished out. It probably extended across the void. A combination of the crack and possible non-rigidity of the turret to the foil could have caused a rapid increase of ΔR.
